Porch Rebuild Case Study

Julie & Frank, L. - North Potomac, Maryland

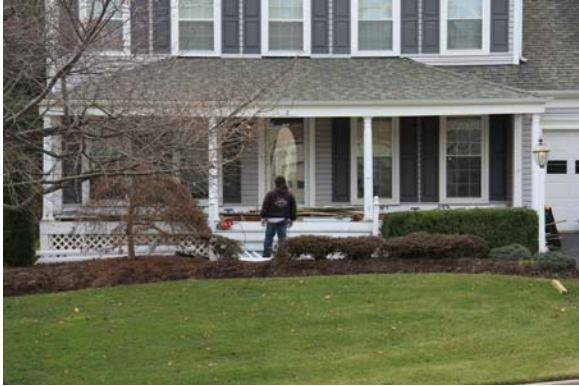
The homeowners contacted our company, through a neighbor's referral, to evaluate some issues that they were having with their front porch. They expressed concern that the porch seemed to be sagging and that, "something was just not right with the way it looked on the house".

After a site visit and preliminary visual inspection of the porch structure, including the decking, steps, columns, and railing system, it was determined and quite evident that the porch needed extensive repairs. It appeared that the previous owners, in an attempt to "pretty up the home" to put it on the market, replaced the rotted front steps with interior grade stair tread material, patched the holes in the rotting columns and decking with wood filler and then just coated over all of the remaining sub-rotted surfaces and railings with a fresh coat of paint. At the time of our visit all of the poorly chosen lumber was beginning to rot again and there were signs the deck was "falling" away from the house. A closer inspection, revealed by crawling underneath the porch, found that the original home builder of the porch failed to meet standard building codes. There were not enough posts, beams and footings for the span and size of the porch. The columns chosen for the porch were not the proper load bearing type. The columns also were installed in a way where the overhead beam of the porch ceiling did not line up the load bearing floor beams. The 2x10 beams that were spliced together were not thru-bolted and not placed over their installed posts and footings. Finally, it was revealed, the ledger board that adjoins and attaches the complete deck structure to the house was only nailed to the house with interior grade "bright" finishing nails, that were corroding. There were sections of this board where you could fit two fingers in between the board and the house, showing just how far the deck had pulled away. The last major discovery was that the 2x8 floor joists were only "toe nailed" into the ledger board and outer beam boards, instead of the required joist hangers. When we left the job site we politely told the homeowners not to slam the front door too hard, that if they did, their front porch might end up in the front yard. In all seriousness this was how precarious the porch condition was determined to be in.
